2023C001 - SECTION XX-DESIGN STUDY REPORTS
EKLUTNA WATER TREATMENT FACILITY
SHIP CREEK WATER TREATMENT FACILITY
WELL #12

1.0 Executive Summary

Eklutna Water Treatment Facility (EWTF) has building damages (including door, ceiling, wall, floor, and exterior finish) sustained by the M7.1 earthquake on November 30th, 2018. This project includes the repair of the existing facility and restoration to its preexisting (pre-disaster) condition.

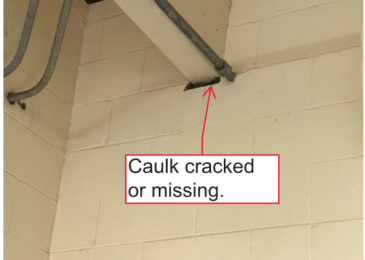
B6	Cracked of Missing Caulk at Purlin Ledge	203 ft / 50 ft	Remove damaged caulking, then reinstall new caulking	<p>Damage Description Photo# 8</p> <p>Caulk at purlin ledge cracked or missing, painted.</p>

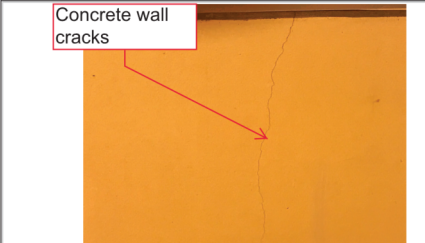
B8	Cracked Concrete Walls	1,298 ft / 1,176 ft	Remove paint 3” each side of cracked mortar joint; Seal crack outlets, inject epoxy, grind smooth (all faces); repaint to match surrounding (649 sf)	<p>Damage Description: Photo# 11</p> <p>Concrete wall cracks, painted.</p>

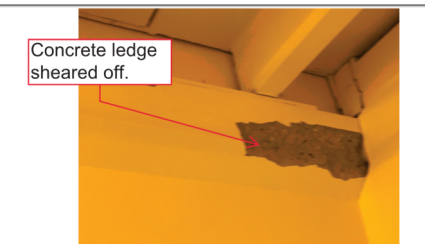
B9	Loose Bracket supporting 6” Roof Drainpipe	1 bracket / 1 bracket	Remove broken bracket; Provide new bracket and anchor to existing wall; re-slope pipe to provide proper drainage	No FEMA Photo
B10	Sheered Concrete Ledge	8 ft /	Install new 3/16” x 2” concrete screws @ 4” on-center each way, reinforce with 4x4 welded wire fabric and patch with Quikrete Patch	<p>Damage Description: Photo# 21</p> <p>Roof panel support ledge sheered off, painted.</p>

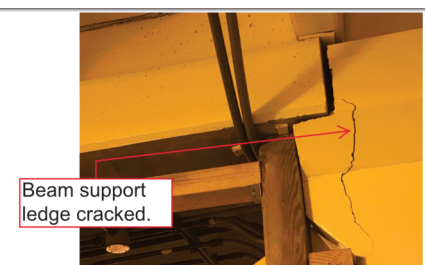
B11	Dropped Concrete Beam Ledge Support	9 ft /	Remove corbel and all cracked concrete; provide new reinforcing and adhesive dowel to existing wall; recast new concrete corbel; install new bearing pad; remove shoring	<p>Damage Description Photo# 22</p> <p>Concrete structural beam support ledge cracked.</p>

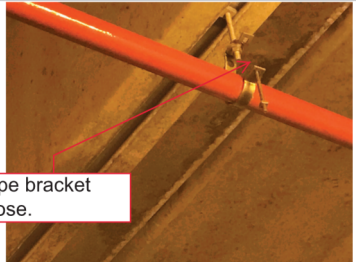
D3	Loose Bracket supporting 2" natural gas piping, painted	7 brackets/ 9 brackets	Remove broken bracket; replace with new bracket	<div style="float: right; border: 1px solid black; padding: 2px;">Photo# 12</div> <div style="border: 1px solid black; padding: 2px;">Damage Description Pipe bracket loose, 2 inch painted.</div>

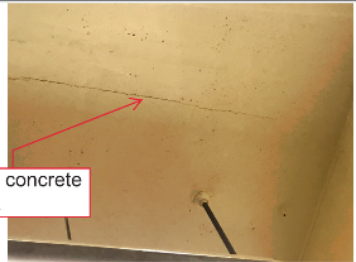
D4	Loose Bracket supporting 4" water line, painted	1 bracket / NOT FOUND	N/A	No FEMA Photo
D5	Cracked Concrete ceiling	42 ft / 72 ft	No repair; part of roofing	<div style="float: right; border: 1px solid black; padding: 2px;">Photo# 18</div> <div style="border: 1px solid black; padding: 2px;">Damage Description Concrete ceiling cracks.</div>

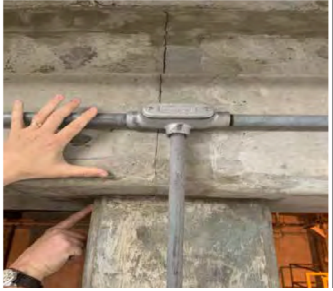
<p>3. Concrete cracking throughout.</p>
A2	Cracked Concrete Corbel	2 ft / 14 ft	Remove cracked grout; reinstall flexible sealant	<p>4. 2 SF of concrete corbel</p>

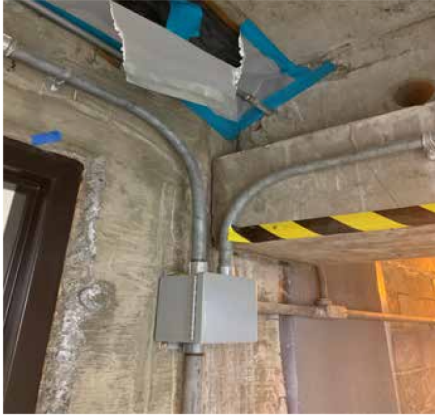
A3	Damaged Concrete	4 ft / REPAIRED	Plastic and blue tape may be removed – this is part of the 2018 repair project and is not damaged

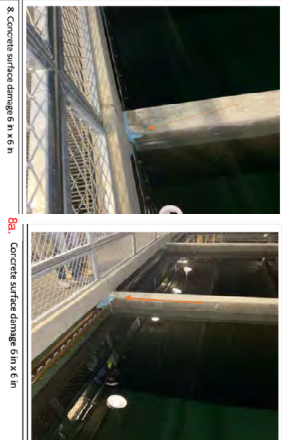
<p>7. Concrete damage 4ft long X 1 ft wide</p>
B				
Floor				
B1	Damaged Concrete, 6” x 6”	0.25 sf / 3.0 sf	Seal crack outlets, inject epoxy, grind smooth (all faces)

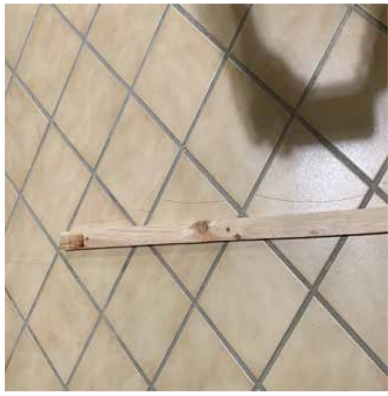
B2	Cracked Tiles, 7.5” x 7.5”	9 tiles / 10 tiles	Remove broken tile, replace with similar tile

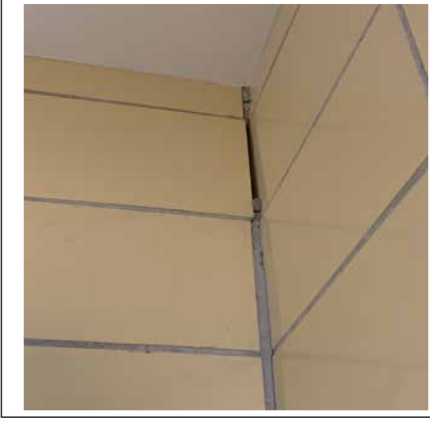
C	Exterior Walls			
C1	Cracked Concrete (throughout outside of window)	45 ft / 194 ft	Remove paint 3" each side of each crack; Seal crack outlets, inject epoxy, grind smooth (all faces); repaint to match surrounding	No FEMA Photo
C2	RegROUT of Exterior Concrete Wall	44 ft / 48 ft	Remove paint 3" each side of each crack; Seal crack outlets, inject epoxy, grind smooth (all faces); repaint to match surrounding (24 sf)	No FEMA Photo
D	Interior Walls			
D1	RegROUT Throughout	176 ft / see below	Non-distinct, split into two categories below	
D1.i	Tile RegROUTing	85 ft	Remove existing cracked grout, reinstall new grout to match surrounding

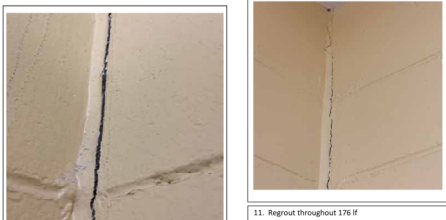
<p>9 RegROUT throughout 176 lf</p>
D1.ii	CMU Corner RegROUTing	138 ft	Remove paint 3" each side of crack; Remove existing cracked grout, repoint with new grout or flexible sealant; repaint to match surrounding

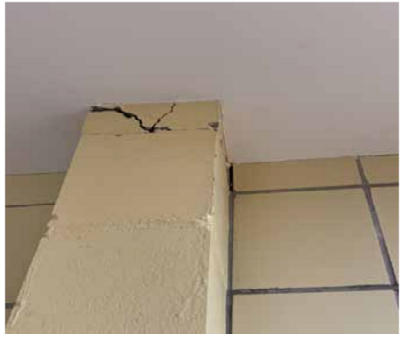
D2	Cracked CMU	12 ft / 9 ft	Remove broken face shell (15 loc); replace face shell with new face shell to match (15 loc); adhesive in place; repaint to match surrounding (14 sf)	12. CMU cracking throughout 121F

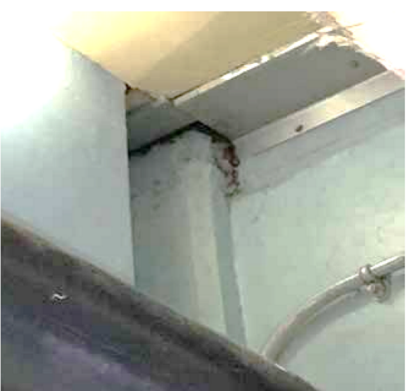
D3	Damaged GWB (4x6)	20 ft / REPAIRED	N/A	13. GWB 4x6

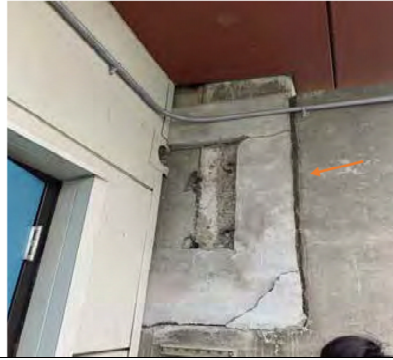
D4	Damaged Concrete Wall, Exterior	6 sf / 6 sf	Remove patched concrete; cover and finish as needed	14. Concrete wall damage 3 ft x 2 ft

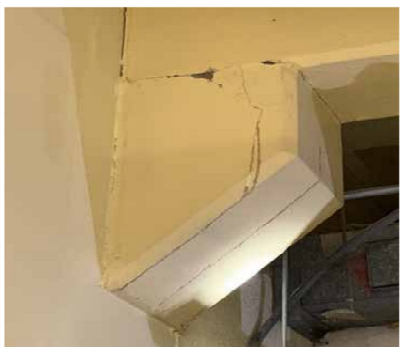
D5	Split Concrete Support	31 ft / 31 ft	Seal crack outlets, inject epoxy, grind smooth (all faces); repaint to match surrounding	15. Concrete support beam
