**16716 FIRE HOUSE LANE
EAGLE RIVER, ALASKA**

LIMITED HAZARDOUS BUILDING MATERIALS INVENTORY

MARCH 2021

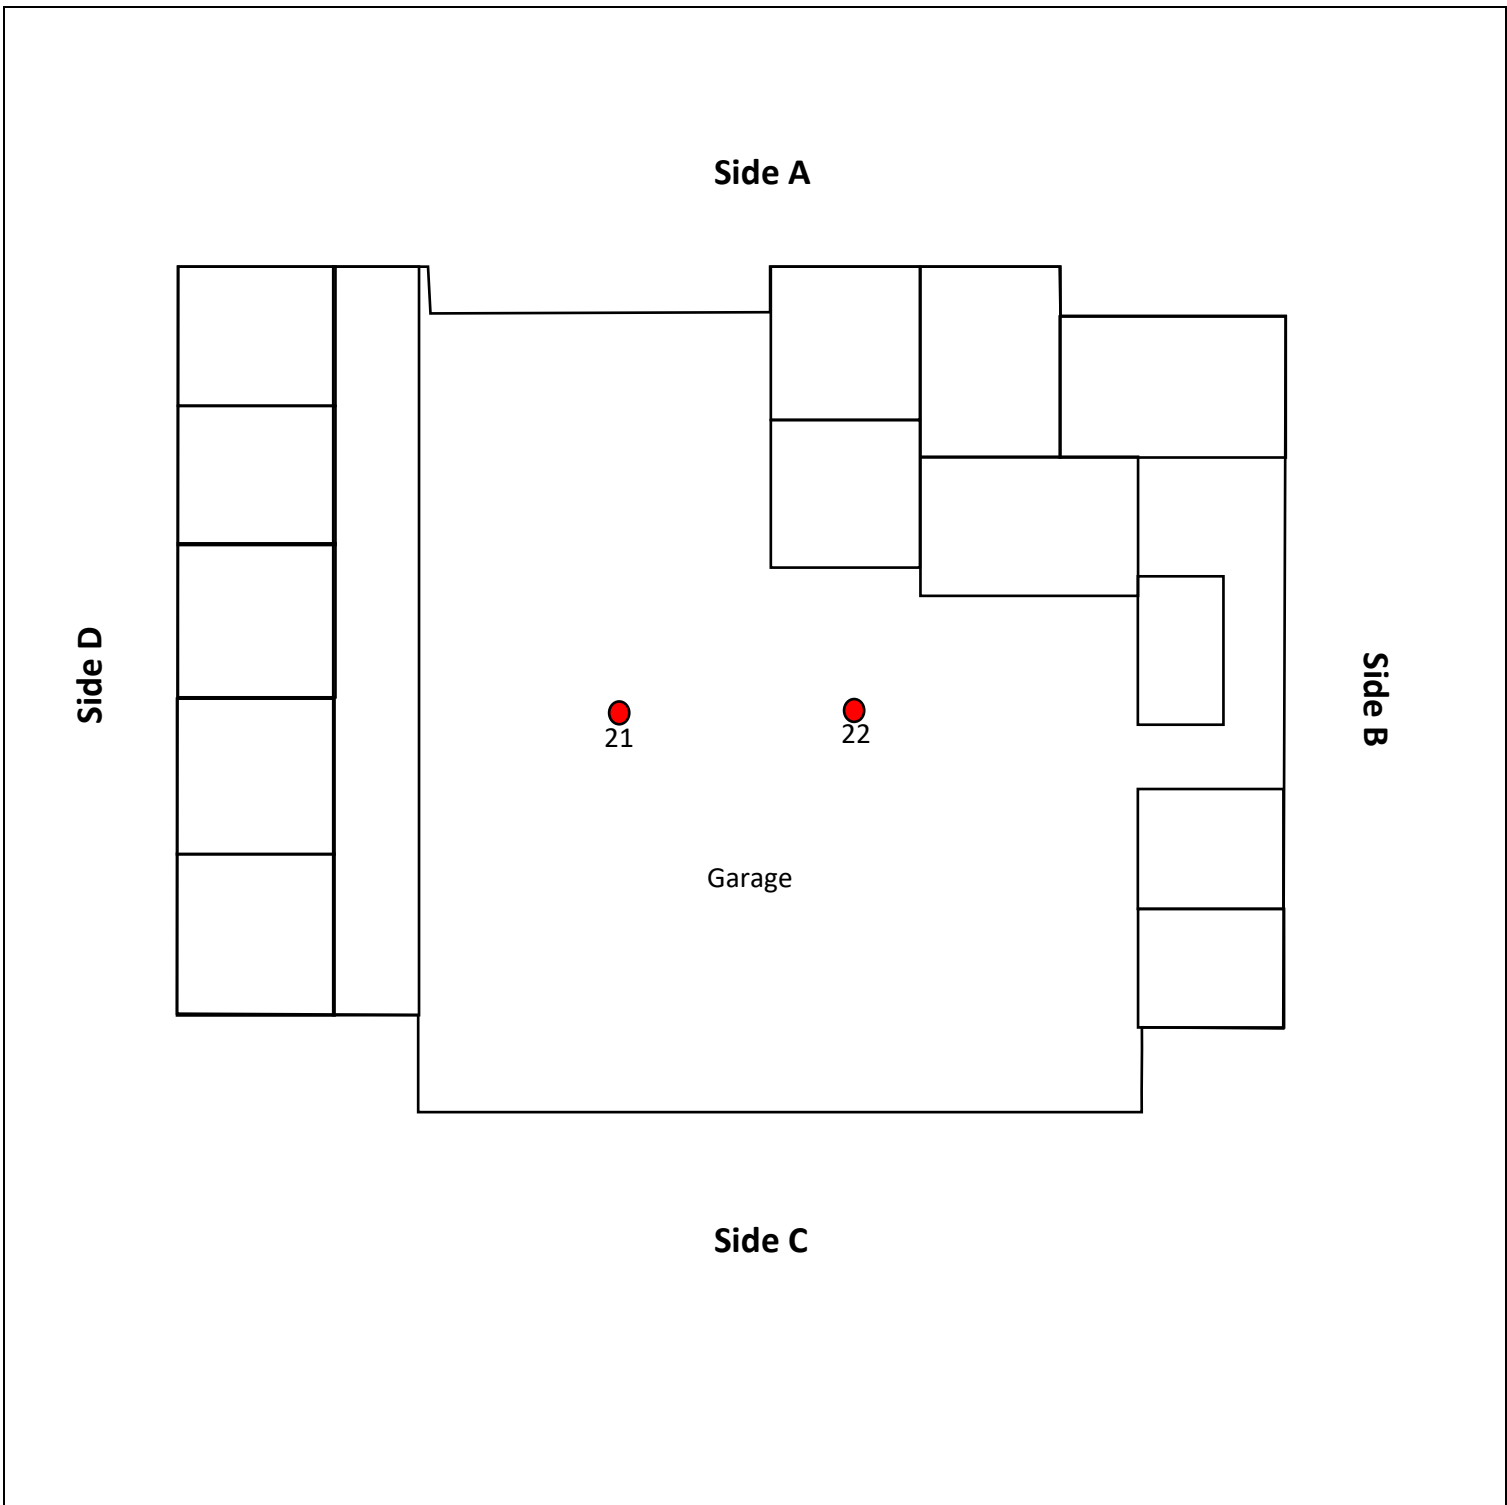
Positive Lead Reading Locations

A total of 106 XRF readings were taken from selected painted surfaces, divided into various testing combinations. Readings taken from the yellow striping paint on the garage floor exceeded the EPA regulatory limit of 1.0 mg/cm² for lead.

XRF ID #	Testing Location	Building Component	Approximate Area (estimated total for unit/common area)
21	Garage Floor	Yellow Striping Paint	6 Square Feet
22	Garage Floor	Yellow Striping Paint	6 Square Feet

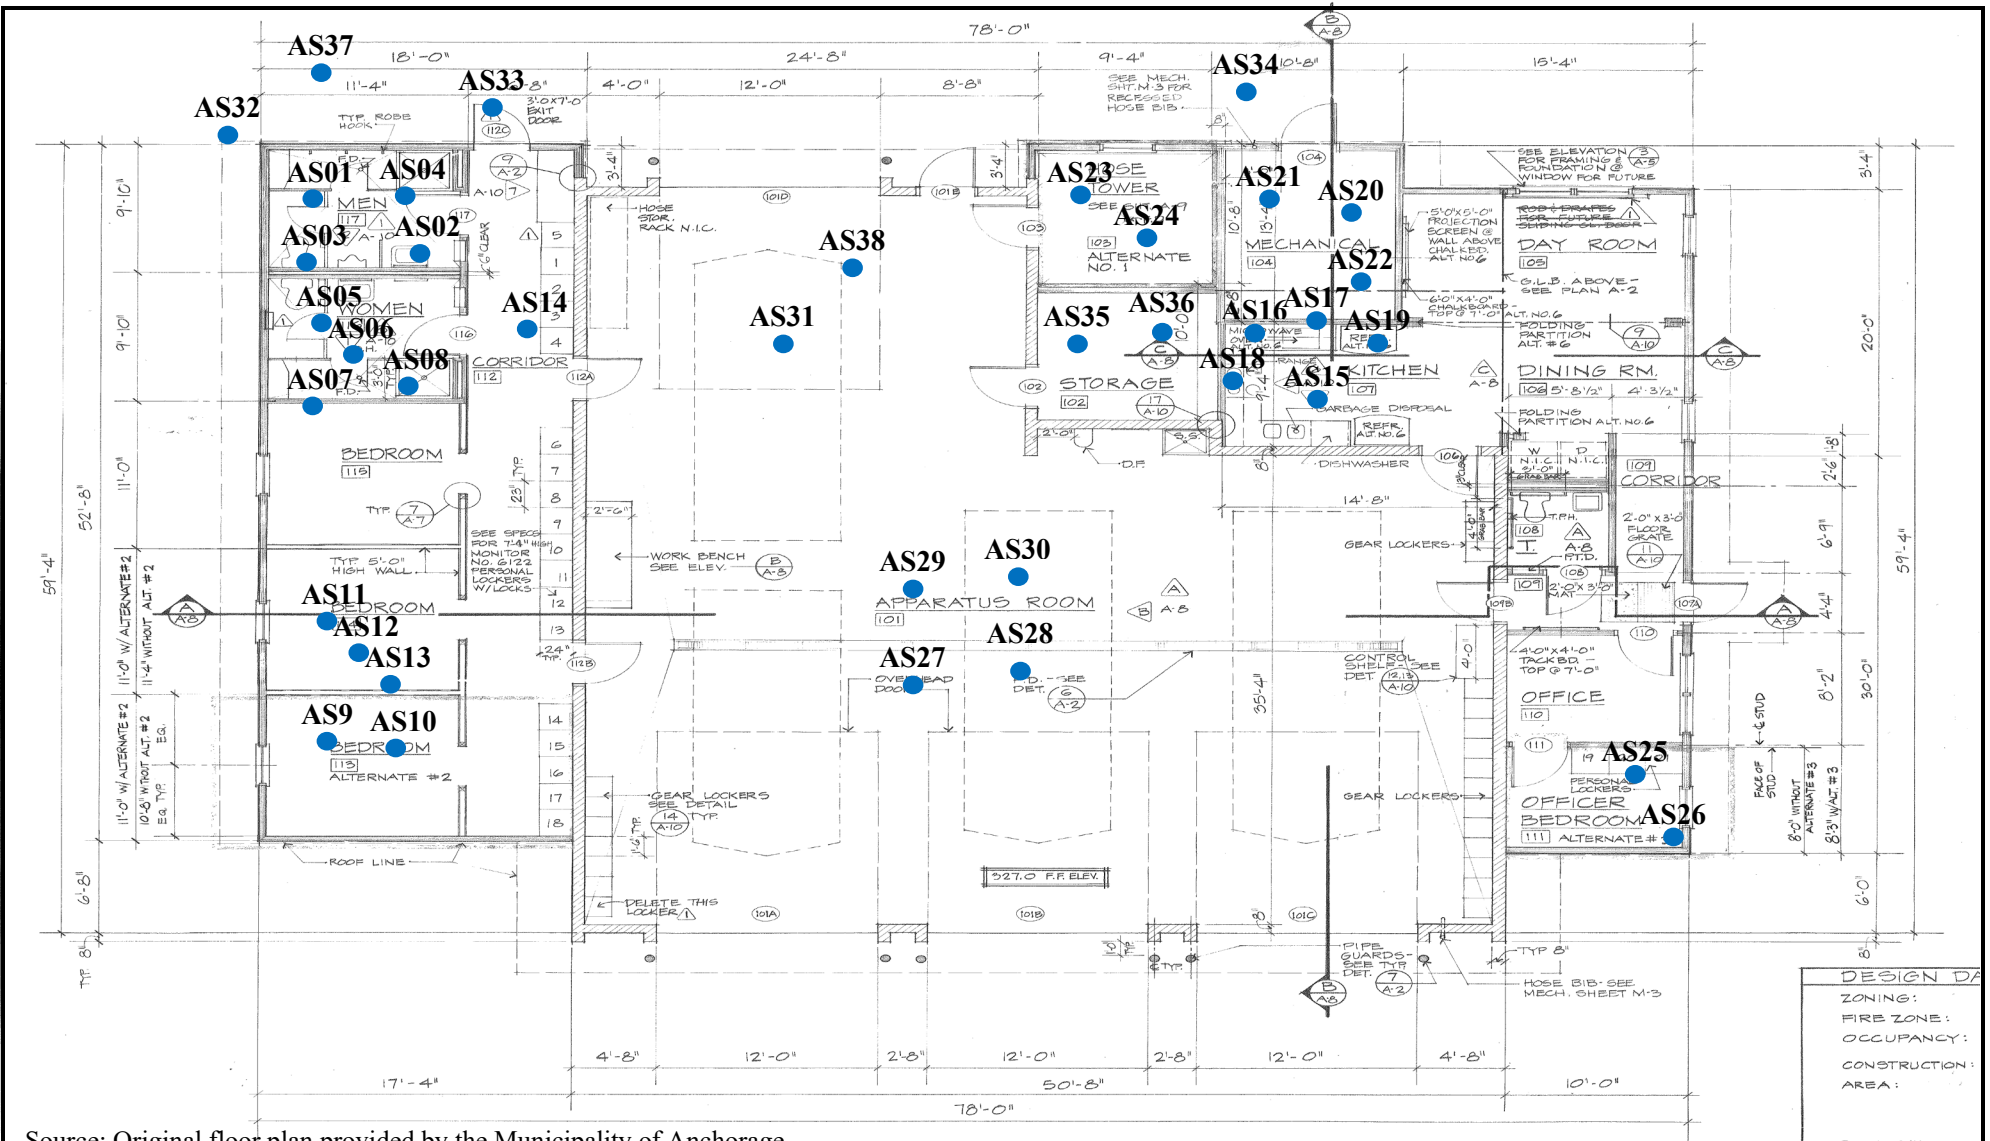
PACBM Sample Locations

A total of 66 bulk samples (38 samples with 28 additional layers) were collected from PACBM identified in the inspected portions of the building on the subject property. Each sample was analyzed by EPA Method 600/R-93/116. As described above, according to the NESHAP, ACMs are defined as containing more than 1 percent asbestos. One of the samples collected was originally found to be “asbestos-containing” according to the NESHAP definition. This sample (collected from floor material in the hallway to the north of the engine bay) was further analyzed by a 1,000-point count method to obtain more precise results, and was ultimately found to contain less than 1 percent asbestos. None of the other 65 samples analyzed were found to be “asbestos-containing” according to the NESHAP definition. PACBM PLM analytical data are included in Appendix B.

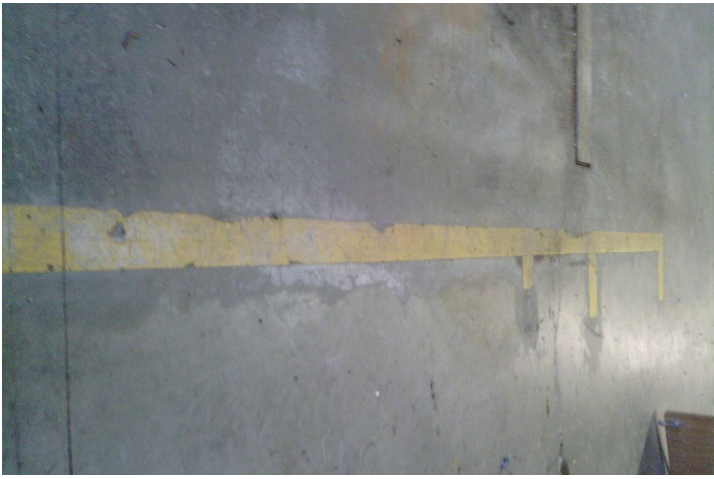
Photo 1: Reading # 21 – Floor Striping in Garage

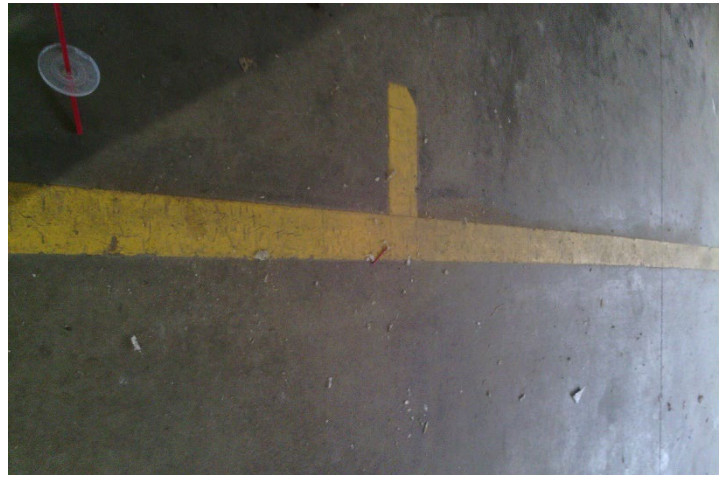
Photo 2: Reading # 22 – Floor Striping in Garage
