# Port of Anchorage Drainage Study, Final Report

**DPW #95-17**

Municipality of Anchorage

March 1997

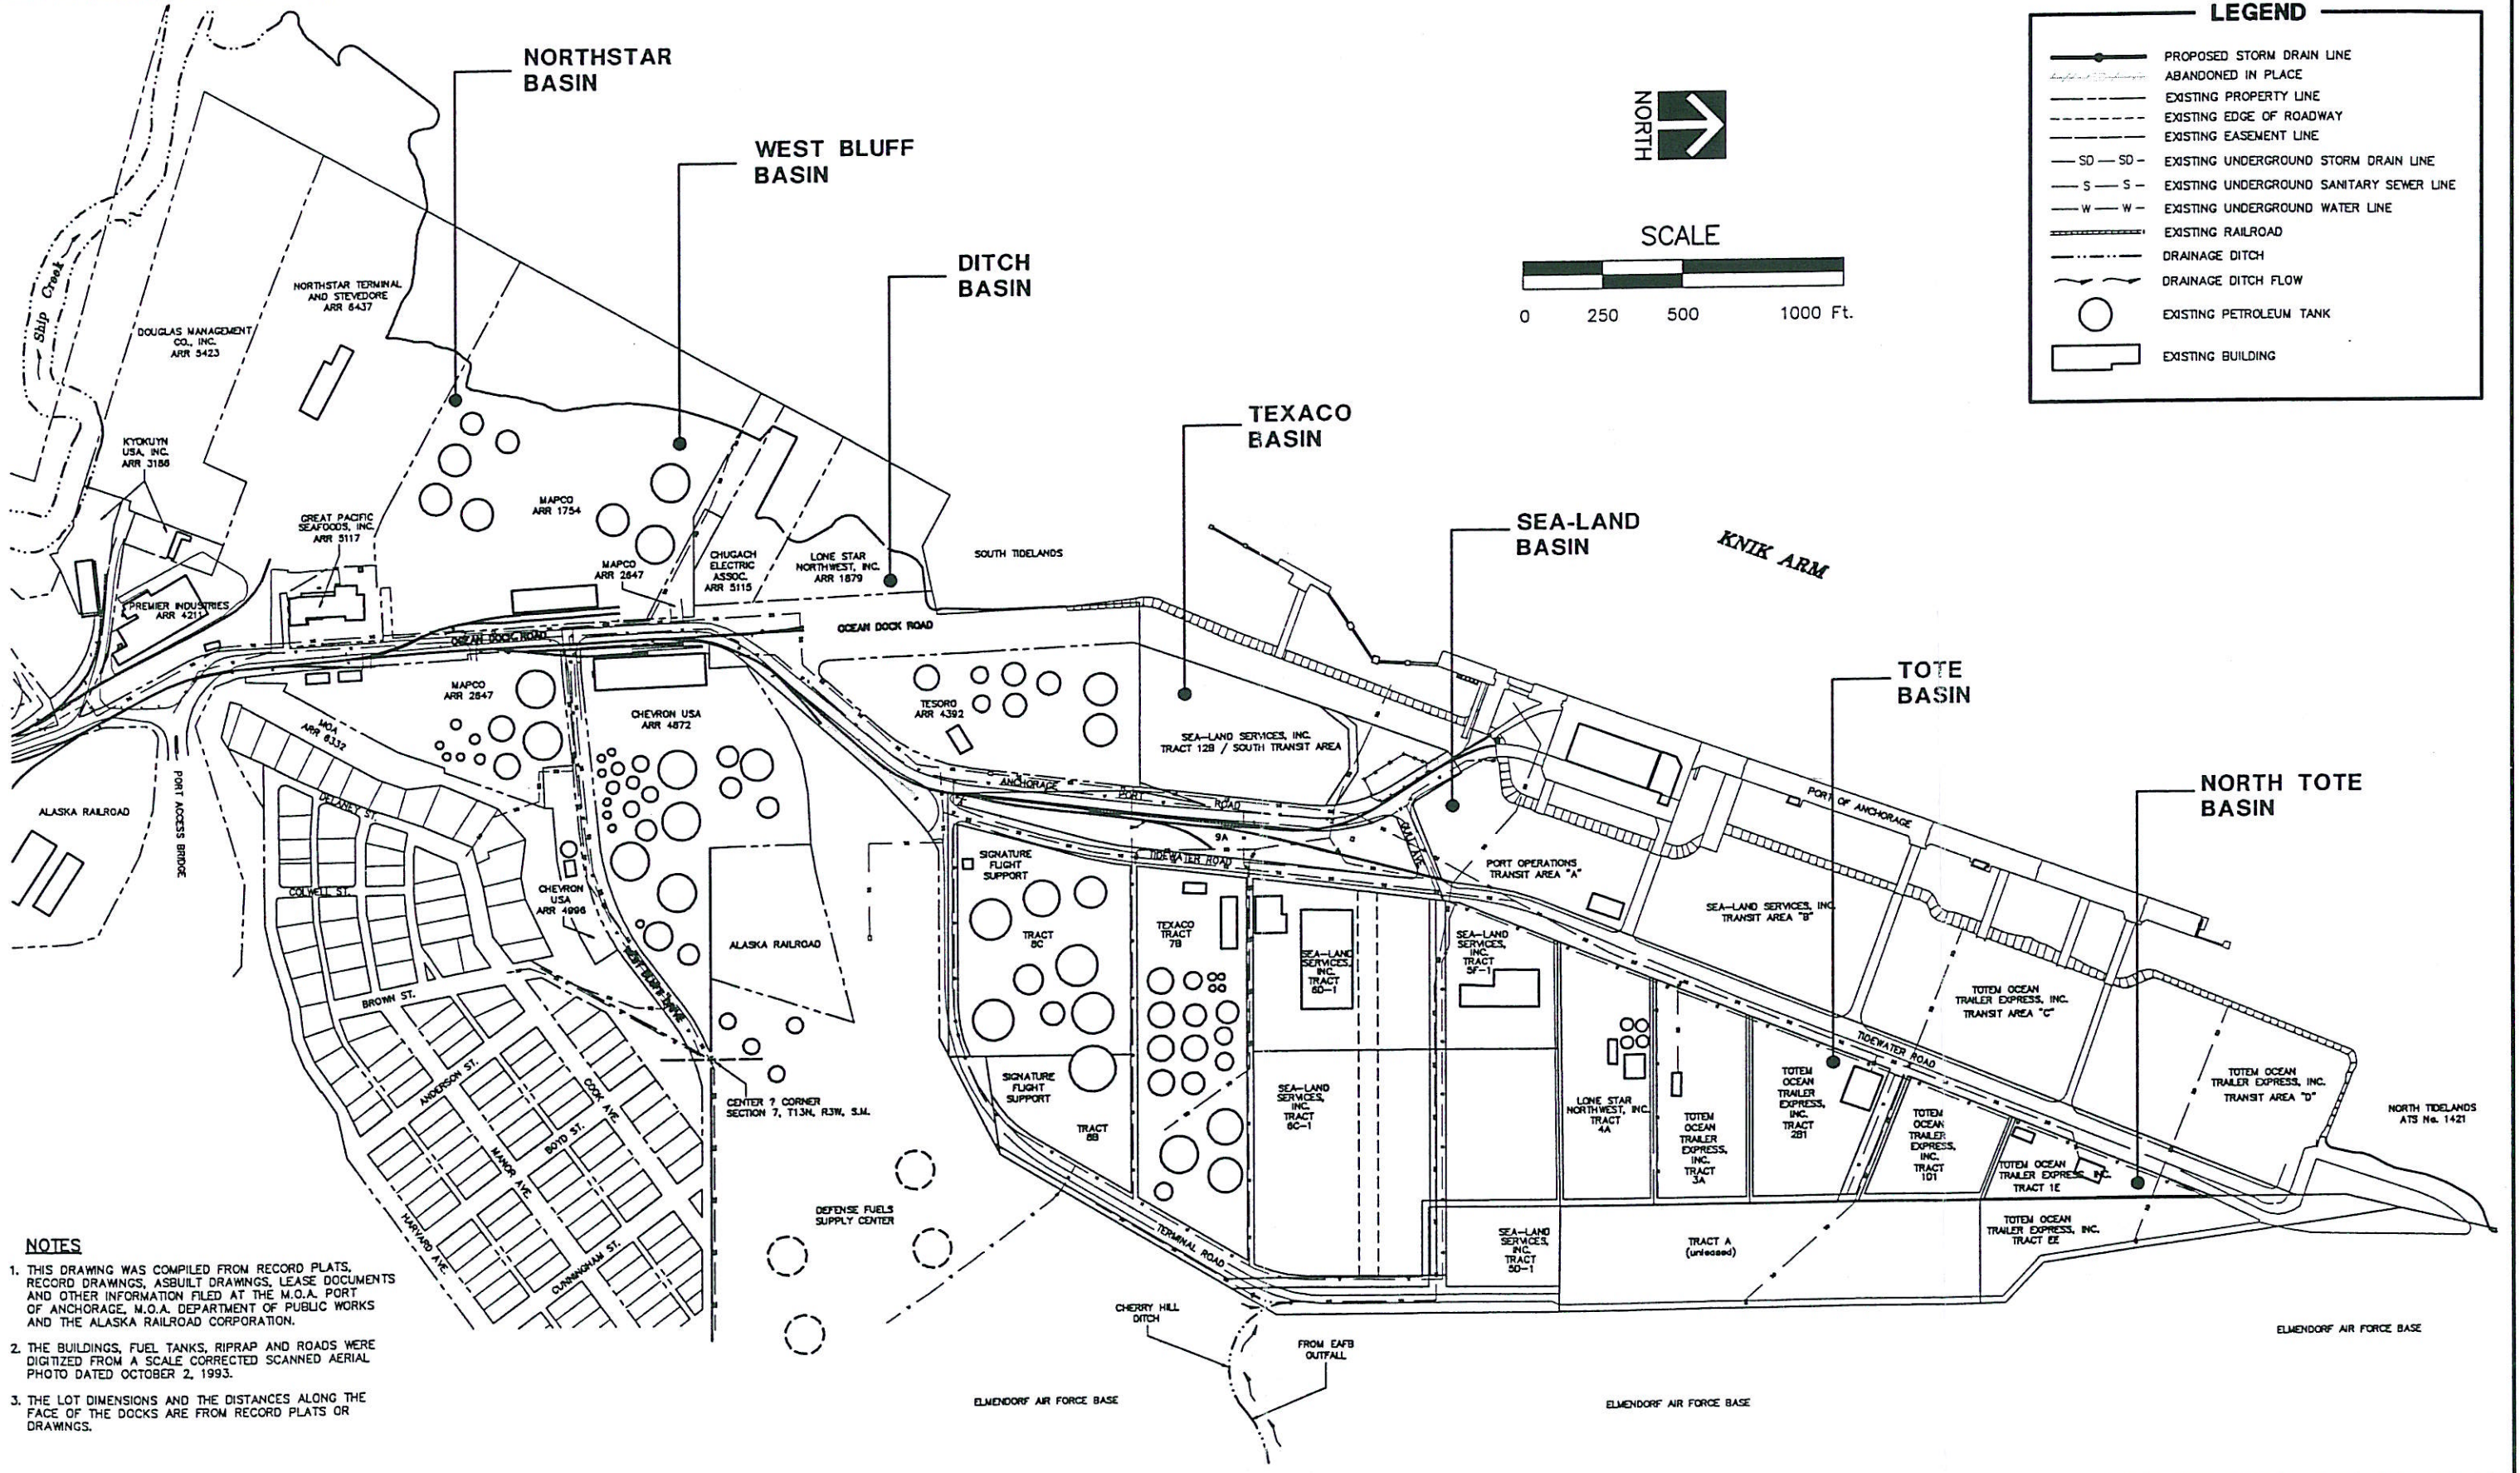
PORT OF ANCHORAGE DRAINAGE STUDY  
 FIGURE 2-1  
 STORM DRAIN SYSTEM

Inspection of the storm drain system found the manholes to be in fair condition and the pipes to be in poor condition. The pipe leads adjacent to the manholes were found to be severely corroded. At some manholes, the pipe leads were completely corroded away. Heavy deposits of silt were observed on the crown of the pipes and on the manhole walls, indicating the system has been routinely surcharged with tide water. Twelve to 20 inches of silt was also observed in the bottom of the manholes. At the time of inspection, the perforated drainage system was frozen and the catch basins could not be inspected. Up to 3 feet of ice was noted to cover Tract A and Tract EE. The outfall was found but was not inspected. See Appendix C, Pipeline Inspection Results, for a detailed description of the inspection.

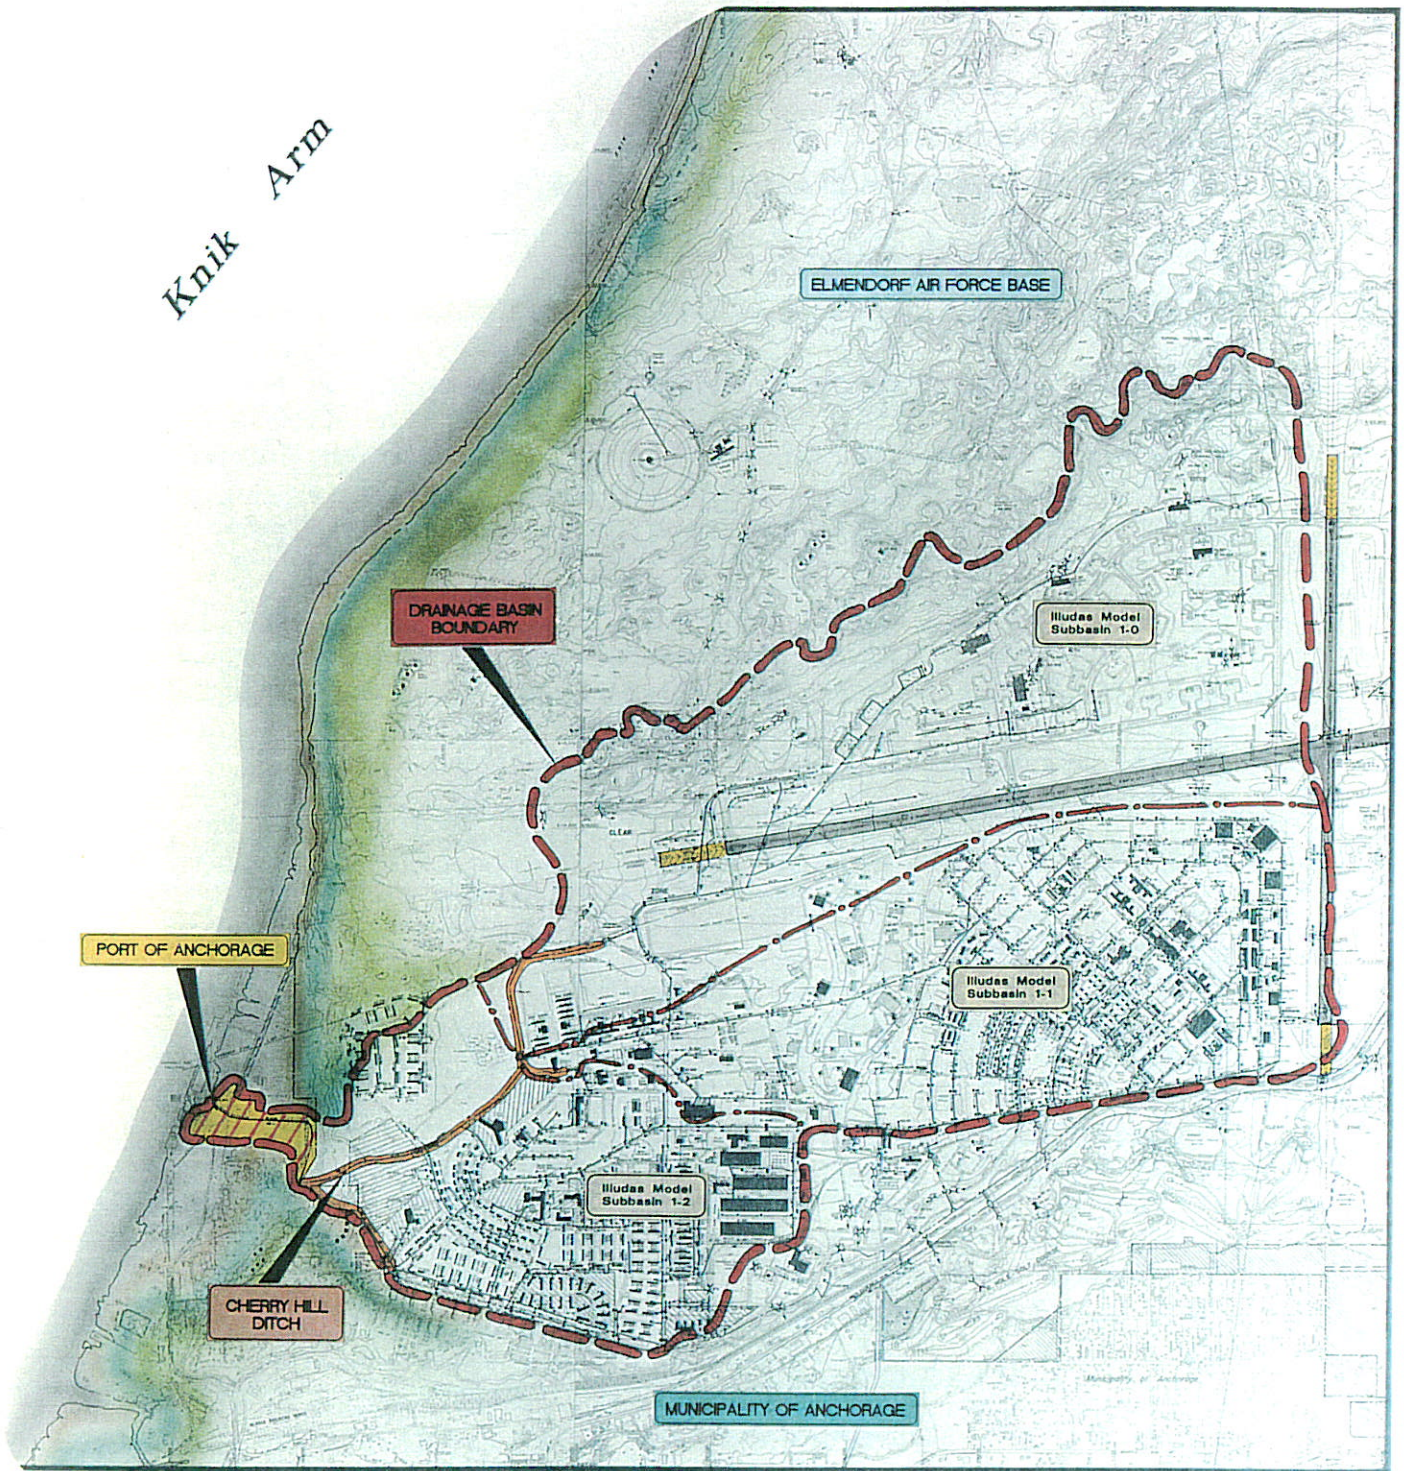
Port of Anchorage Drainage Study  
 CHERRY HILL DITCH and SEA-LAND SYSTEM  
 DRAINAGE BASIN

The CCTV survey and inspection of the existing storm drain system found the manholes and pipes within the eastern portion of the storm drain system to be in fair condition. Most of the defects were found in the western, or the downstream, segment of the system. A segment east of Gull Avenue was particularly defective. An obstruction within this segment

prevented the videotaping of approximately 230 feet of pipe. Corrosion was not excessive in most of the upstream segments of the Sea-Land system. Several protruding pipe laterals were observed throughout the system. Protruding laterals are considered defects for either slipline or insertion lining rehabilitation. Several manholes did have evidence of structural defects, such as cracks or missing mortar, and signs of infiltration. The last 100 to 150 feet of outfall pipe has separated at several joints and is exposed. Runoff discharging from the system is washing away the silts that previously covered the pipe and redepositing them underneath the berths. This erosion of the silt material is causing a gully to migrate toward a paved parking area (Transit Area A) east of the Port offices. See Appendix C, Pipeline Inspection Results, for a full summary of the CCTV survey and inspection of the existing Sea-Land storm drain system.

During the interview process, Port of Anchorage personnel identified the Sea-Land system's outfall as a major drainage problem because of the sediment buildup at the outfall. This build up was reported to potentially affect ships moored at the Port dock. Another problem identified by Port personnel that was the collapse of a portion of this system caused the land to slump at a location near the Sea-Land office building during the summer of 1995.

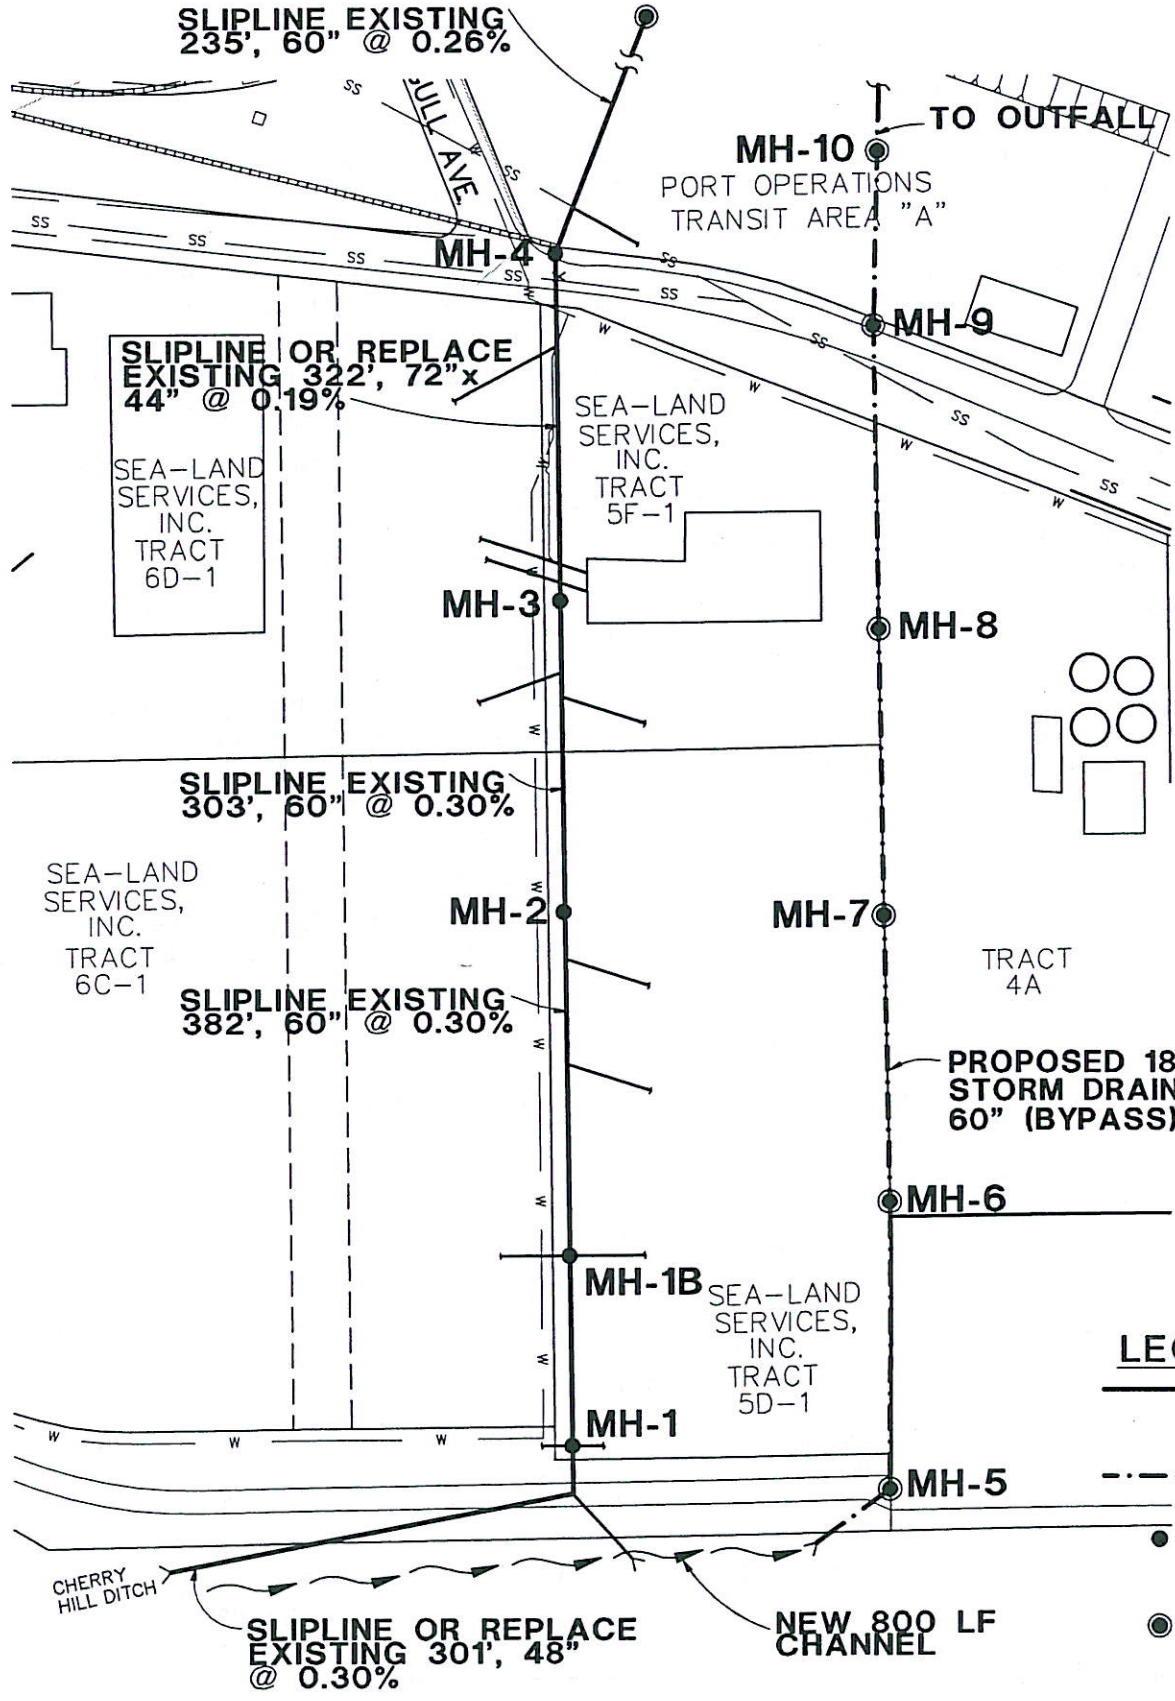
<sup>c</sup> Requires 322 feet of 72-inch x 44-inch arch pipe and 301 feet of 48-inch CMP be replaced.

The systems constructed in this alternative would convey the 10-year, 3-hour event runoff without flooding Port property. The Sea-Land system's outfall also would be repaired. The estimated construction cost of this alternative is \$2,128,568. The estimate project cost, which included estimated cost for project management and design, is \$2,573,439.

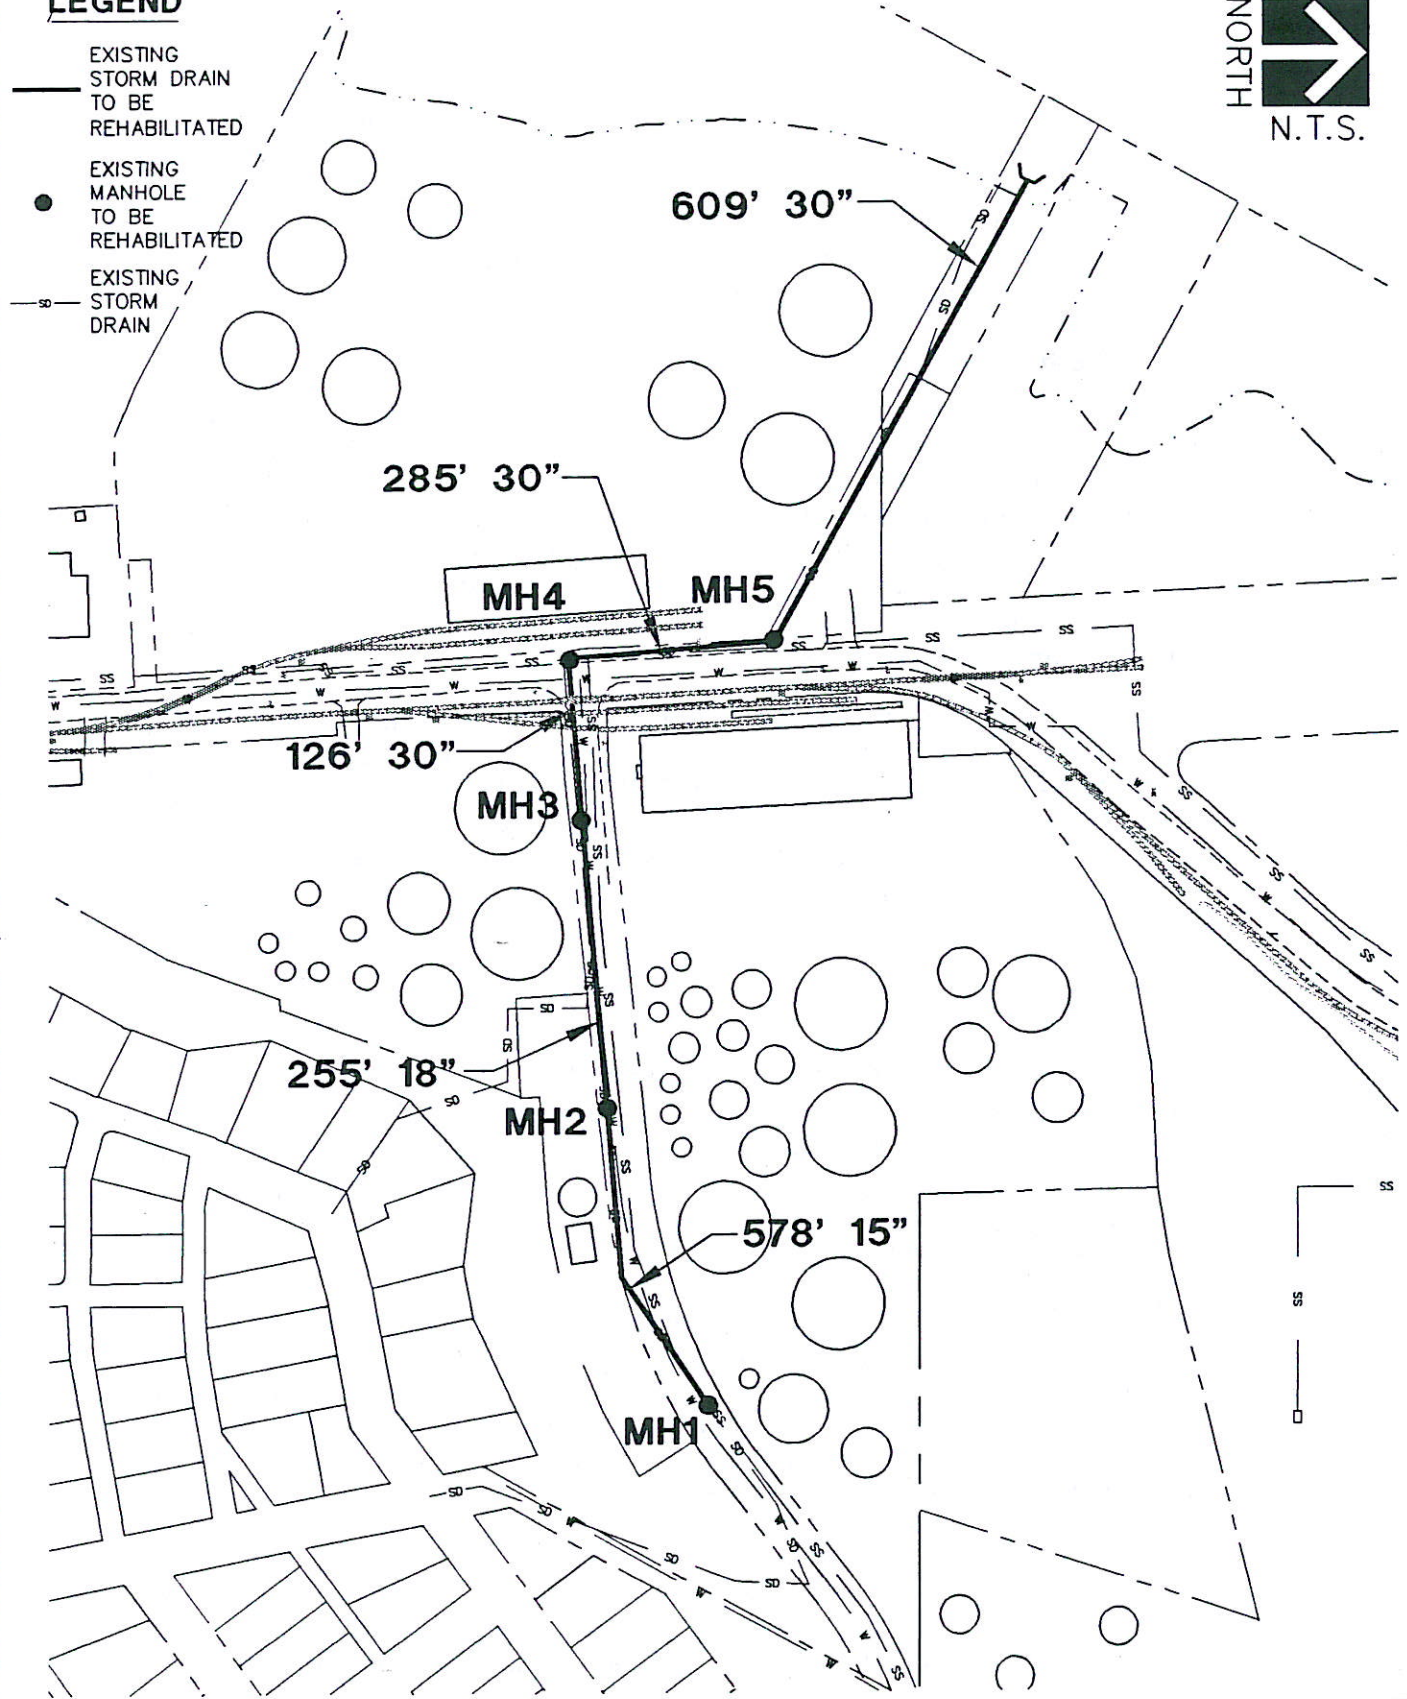
Port of Anchorage Drainage Study  
**WEST BLUFF SYSTEM**  
**STORM DRAIN LINING and**  
**MANHOLE REPAIR ALTERNATIVE**

The CCTV survey and inspection of the existing storm drain system found the existing storm drain system to be in poor condition. Several manholes did have evidence of structural defects, such as cracks or missing mortar, and signs of infiltration. One of the manholes had significant pitting in the concrete wall. Surcharging by the tide water was evidenced by the sediment and muck buildup found in the lower sections of the system. The downstream segments of the storm drain system were found to be completely submerged at low tide. Many of the pipe leads at the manholes showed evidence of corrosion. The exact location of the outfall has not been identified, but a field inspection conducted at low tide identified water emerging from fill at the approximate location of the outfall. This indicates that the outfall is likely completely buried under fill, restricting outflow and probably causing sediment accumulation within the system.

It is recommended to repair the outfall, slipline the pipe, and repair the manholes. As part of the outfall repair, the portion of the line downstream from Ocean Dock Road should be cleaned and inspected. The outfall inspection should be completed before other line repairs. Repairing manholes and lining the pipe would extend the life of the system. Repairing the outfall segment would increase the system capacity by reducing sedimentation within the system. Segments of the system would, however, remain undersized. Estimated construction cost would be approximately \$542,958. The estimated project cost including estimated project management and design costs is \$715,801.

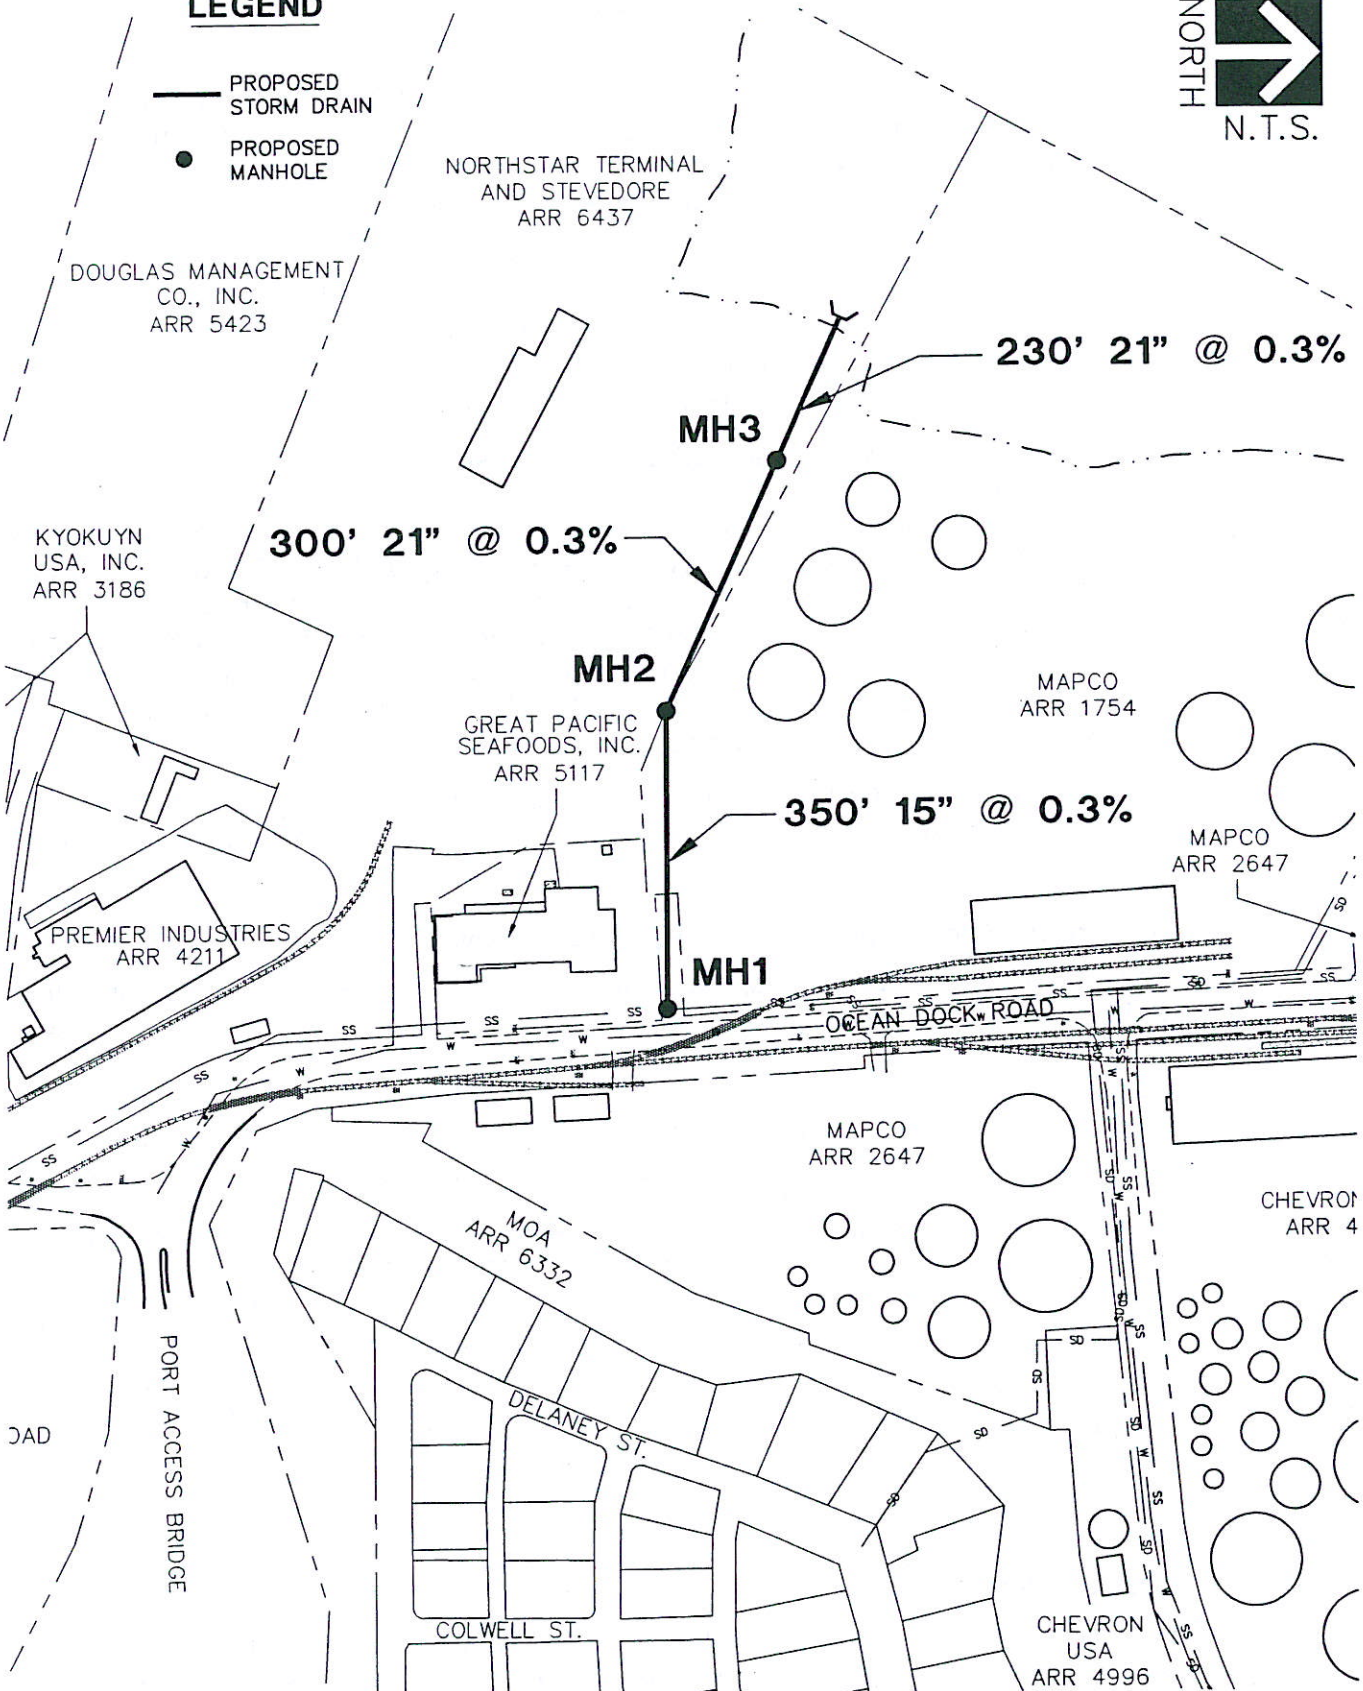
Port of Anchorage Drainage Study  
**NORTH STAR  
 STORM DRAIN SYSTEM  
 REPLACE WITH NEW SYSTEM  
 ALTERNATIVE**

The North Star drainage system could not be found in the field. Information on the system alignment, outfall location, pipe size, pipe material, or invert slope also could not be located. The DPW is not able to maintain the system because of the lack of easements and location information. It is reported the North Star drainage basin is drained by a single-pipe storm system extending from Ocean Dock Road to an outfall into Cook Inlet.

viable alternatives because the existing system could not be evaluated for system failure nor can it be maintained. It is therefore recommended that nothing be completed for this system, unless evidence is provided that shows a reasonable need to construct a new storm drain system.
