**WEST BLUFF DRIVE / OCEAN DOCK ROAD AREA
STORM DRAIN IMPROVEMENTS**

ATTACHMENT D

Port of Anchorage Drainage Study, Final Report

March 1997

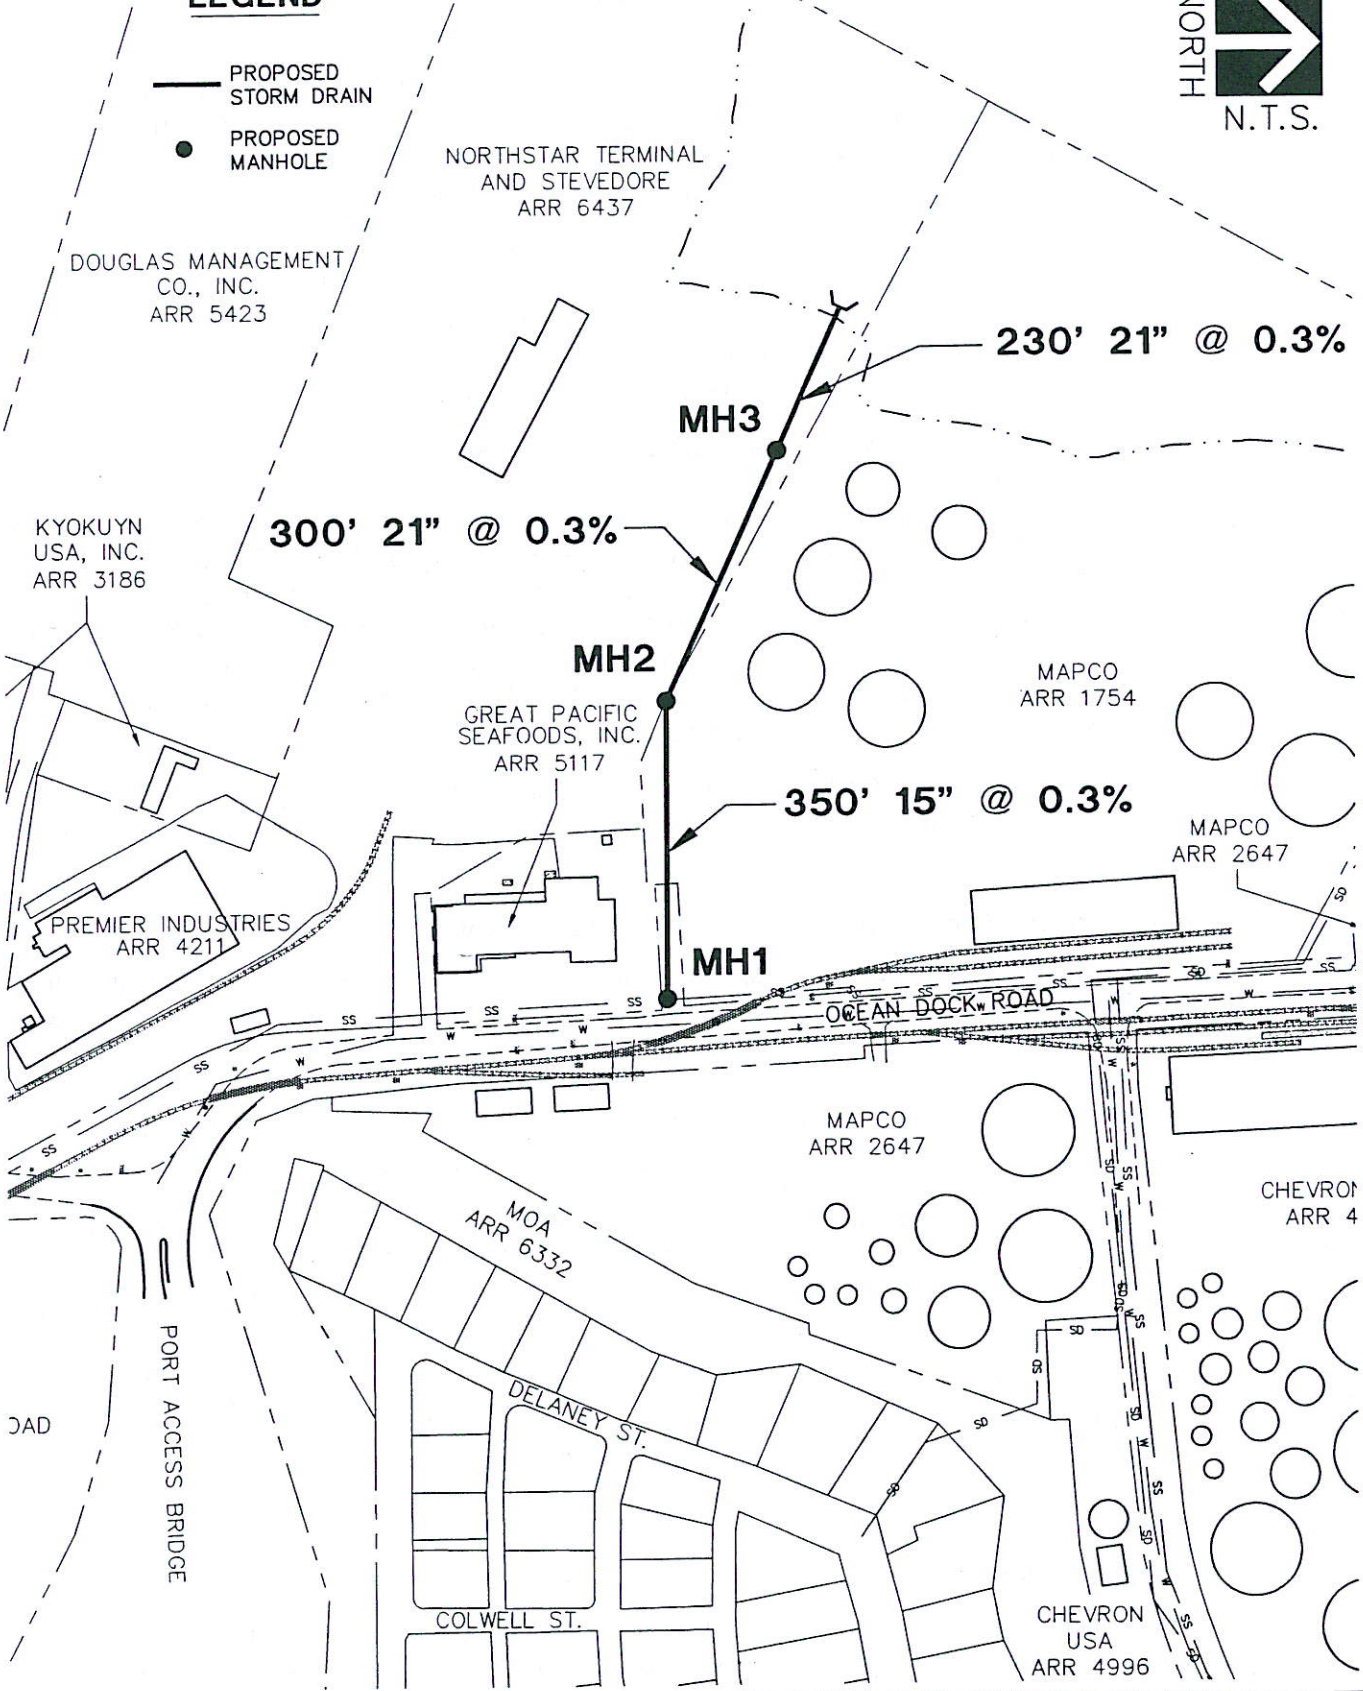
Port of Anchorage Drainage Study
**NORTH STAR
 STORM DRAIN SYSTEM
 REPLACE WITH NEW SYSTEM
 ALTERNATIVE**

The North Star drainage system could not be found in the field. Information on the system alignment, outfall location, pipe size, pipe material, or invert slope also could not be located. The DPW is not able to maintain the system because of the lack of easements and location information. It is reported the North Star drainage basin is drained by a single-pipe storm system extending from Ocean Dock Road to an outfall into Cook Inlet.

viable alternatives because the existing system could not be evaluated for system failure nor can it be maintained. It is therefore recommended that nothing be completed for this system, unless evidence is provided that shows a reasonable need to construct a new storm drain system.
